# FACILITY COMPLIANCE INSPECTION REPORT

## Division of Waste Management Solid Waste Section

**Date of Site Inspection:** February 22, 2012

BFI-Charlotte Motor Speedway Landfill V  
 5105 Morehead Road  
 Concord, North Carolina 28027

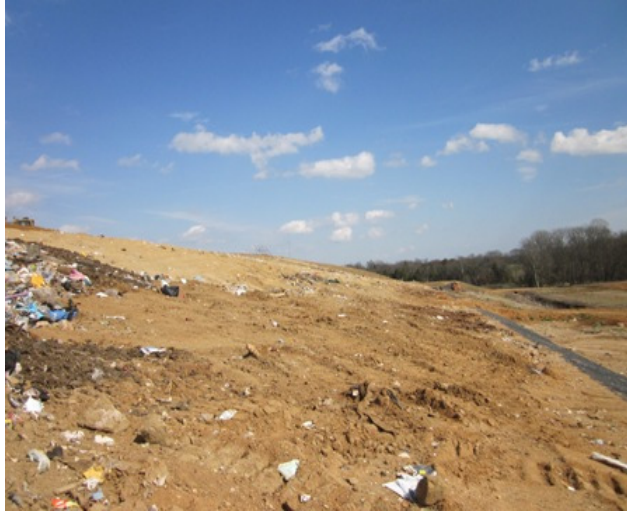
- 15A North Carolina Administrative Code 13B .1626(2)(a) states:** *Except as provided in Sub-Item (b) of this Item, the owners or operators of all MSWLF units must cover disposed solid waste with six inches of earthen material at the end of each operating day, or at more frequent intervals if necessary, to control disease vectors, fires, odors, blowing litter, and scavenging.*

During the inspection, inadequate cover was observed on the eastern slope of Phase 3-Cell 2I where disposal operations had not been active in at least two weeks. A minimum of six inches of earthen material must be provided to all inactive areas of the eastern slope of Phase 3-Cell 2I within **10 days** of receipt of this inspection report.

View of inadequate cover on the eastern slope of Phase 3-Cell 2I.

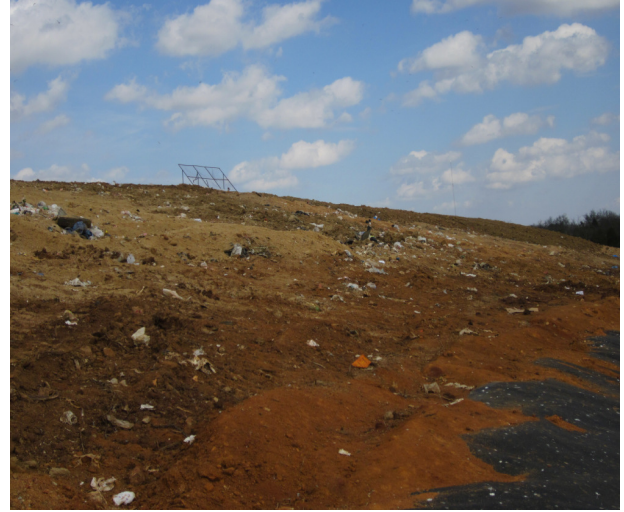
View of inadequate cover on the eastern slope of Phase 3-Cell 2I.
